**Applies To:** Series 2 boards (NSC-100, SSP-D2) and Series 3 boards including the SSP-LX when communicating with OSDP readers.

**Issue:** Series 2 and Series 3 controllers may have issues communicating with OSDP readers.

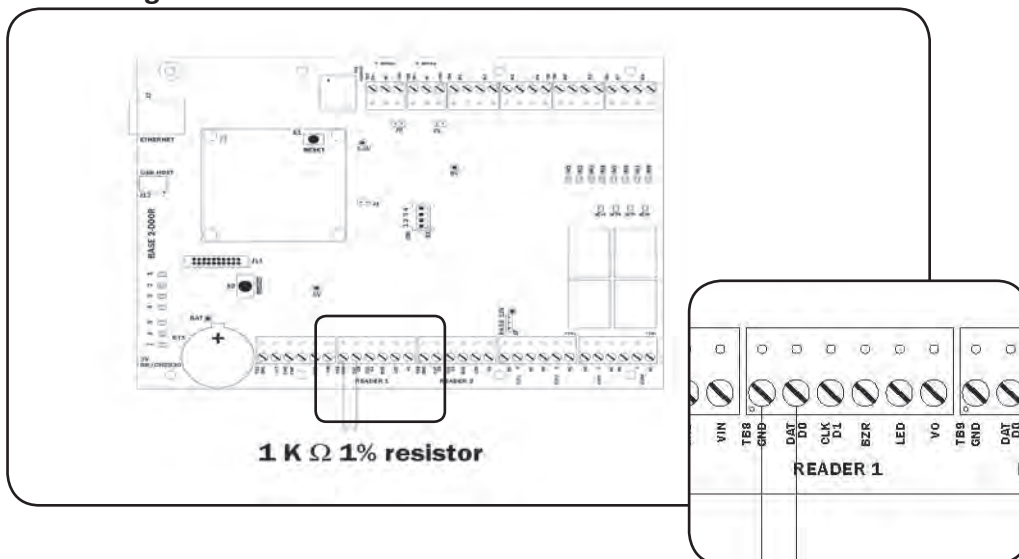
### SSP-LX Diagram

**Summary:** The OSDP readers are interpreting a non-driven 485-line as data in certain installation environments. This interpretation results in a communication fault that will inhibit the panel and reader from properly communicating.

- Place a **1K ohm( $\Omega$ ) 1% resistor** between DAT D0 and GND line

This will create a communication bias that will keep the reader from improperly interpreting data. To function properly, there must be **NO** ground faults in the installation.
